FEBRUARY | 14 | 2024

Facilities Master Plan

Tahoe Truckee Unified School District

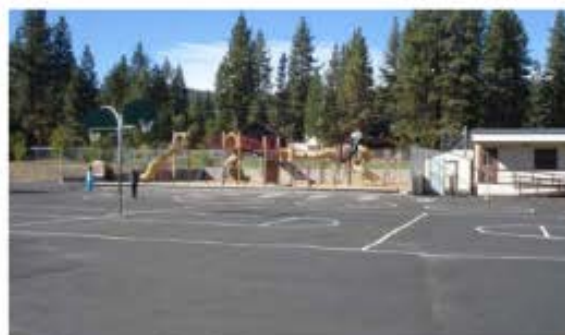
Hard Courts and Play Equipment

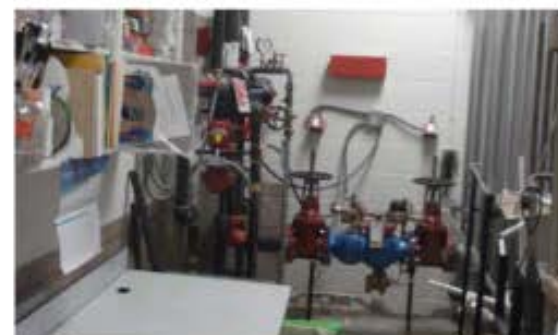
Boiler Room

- HVAC system and boiler plant are outdated.
- Air handling equipment is in poor condition and a complete replacement is recommended.
- Boiler plant pump upgrade is recommended.
- Campus-wide hot and cold water piping shows multiple failures that have been difficult to repair. East wing does not have hot water in classrooms due to damaged piping.

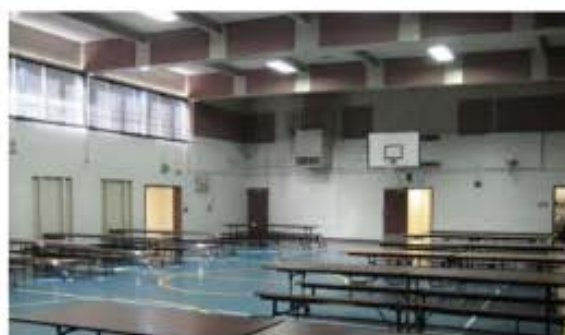
Gym / Multi-Purpose Room

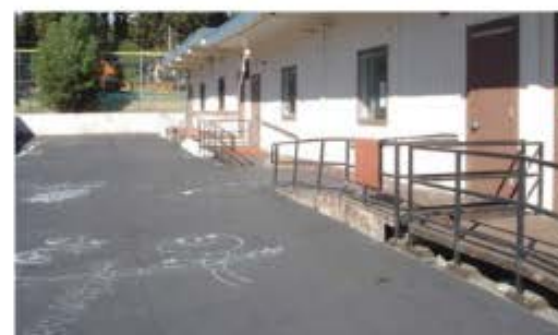
Portable Classrooms

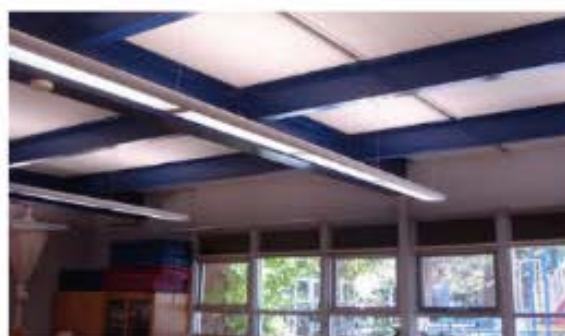
Interior Lighting

- Existing fluorescent lamps have been replaced with energy efficient T-8 lamps in all rooms and all areas have occupancy lighting control.
- Telephone service, main communication systems, data system appear to function properly.
- PA system is separate from the telephone communications system.
- Intercom and master clock/ bell system appear to function properly.
- No known intrusion alarm system observed.
- CCTV security system observed.
- Fire alarm system was upgraded in 2010, but it does not appear to provide full coverage.
- Fire Sprinklers.
- Building is partially sprinklered at the library and computer labs only.
- Boys and girls building is sprinklered.

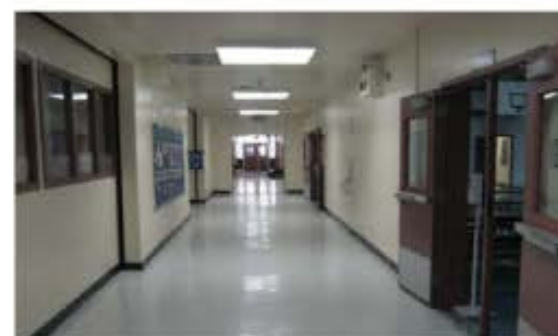
Typical doors and hallway
